**CBA Issues  
Update to the Transit Commission**

**May 31, 2024**

**CONFEDERATION LINE PROJECT:  
TUNNEY'S PASTURE TO BLAIR STATION**

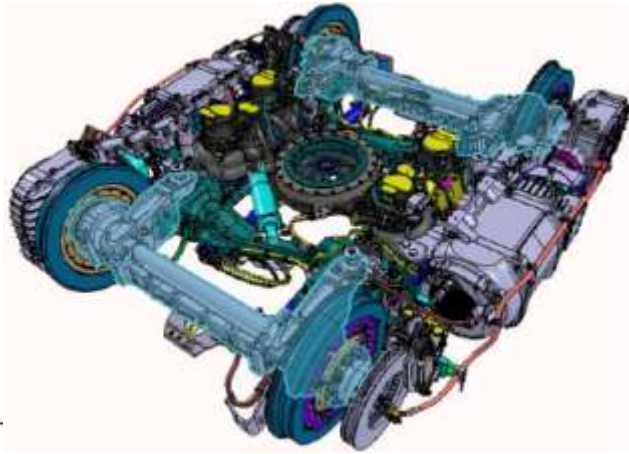
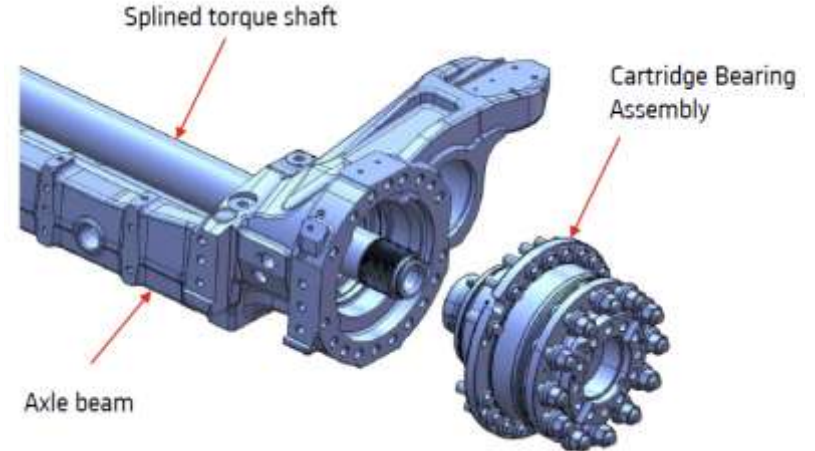
## Sections of the Cartridge Bearing Assembly

1. Nut (crimped on hub)
2. Tab washer (tabs located in hub slots)
3. Seal seat ring
4. Inner ring of small bearing
5. Outer ring of small bearing
6. Bearing preload set washer
7. Spacer
8. Outer ring of large bearing
9. Inner ring of large bearing
10. Rotating hub (centered and bolted to the wheel)
11. Fixed housing (centered and bolted to the structural beam)

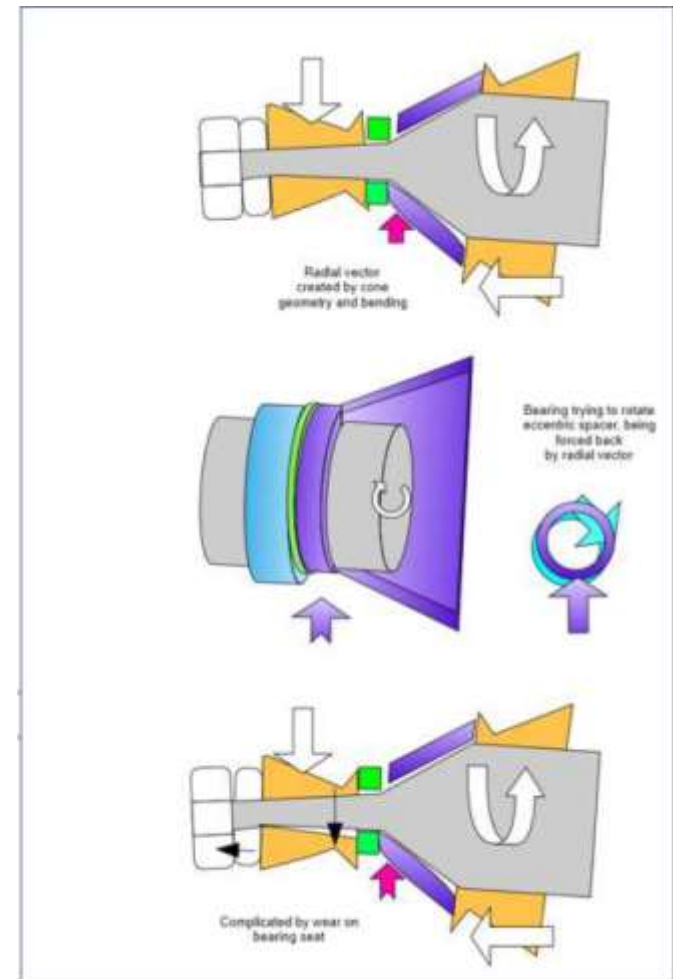
Figure 88 - Mechanism for rotational force and fretting on spacer.

- The axial force on the small bearing inner race seat will promote microscopic fretting movements ('Partial slip') on the seat/bearing interface.
- The small bearing can rotate on the spindle after losing the fit on the spindle, but without any measurable radial play.
- Once this rotation is happening, the nut can unscrew because the rotation has not yet worn the bearing abutments enough to relax the preload in the spindle and eliminate the necessary pressure required to unscrew the nut.

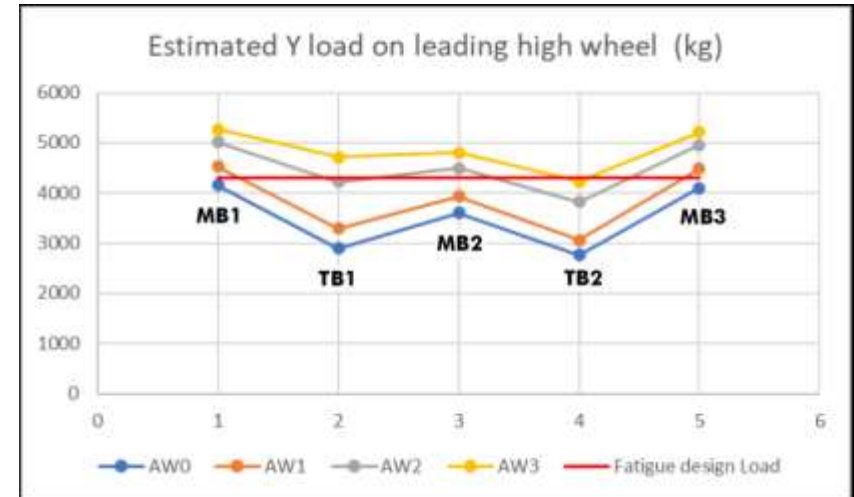
- Lateral Loads increase with passenger loading.
- Forces are higher on leading and trailing motor bogies (MB1 & MB3).
- Lateral Loads on trailing bogies (TB1 & TB2), which are not motorized, are below the 'Fatigue design Load' in AW2 condition.
- Axial play has occurred on all axles.

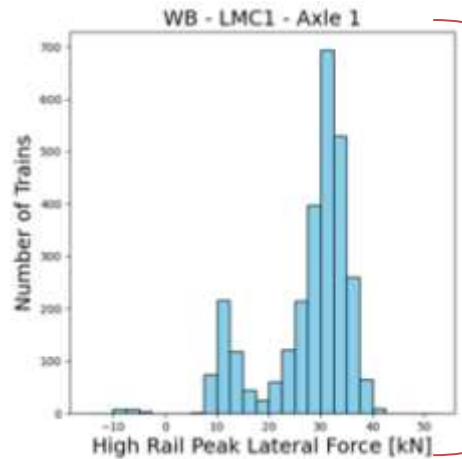
WB-280 peak high rail lateral force when LMC1 is the leading unit

Axle	95 <sup>th</sup> percentile [kN]	Median [kN]	Mean [kN]
1	36.56	30.54	27.69
2	2.33	-4.51	-3.55
3	26.51	20.51	19.26
4	4.39	-1.44	-0.67
5	28.11	22.45	20.7
6	3.04	-2.83	-2.25
7	23.17	17.13	16.06
8	6.35	1.97	2.01
9	32.77	25.97	23.51
10	4.22	-3.28	-2.4

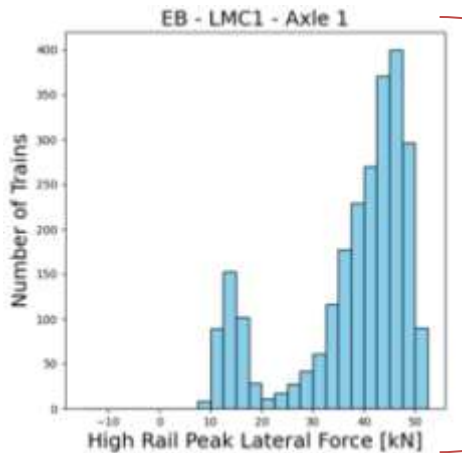
EB-280 peak high rail lateral force when LMC1 is the leading unit

Axle	95 <sup>th</sup> percentile [kN]	Median [kN]	Mean [kN]
1	49.71	41.67	37.83
2	6.22	-5.53	-4.13
3	37.72	30.93	28.57
4	4.88	-1.38	-0.46
5	44.25	35.25	33.1
6	5.73	-3.21	-2.34
7	34.38	27.09	25.35
8	5.54	1.27	0.61
9	47.99	39.27	36.16
10	7.73	-4.24	-2.59

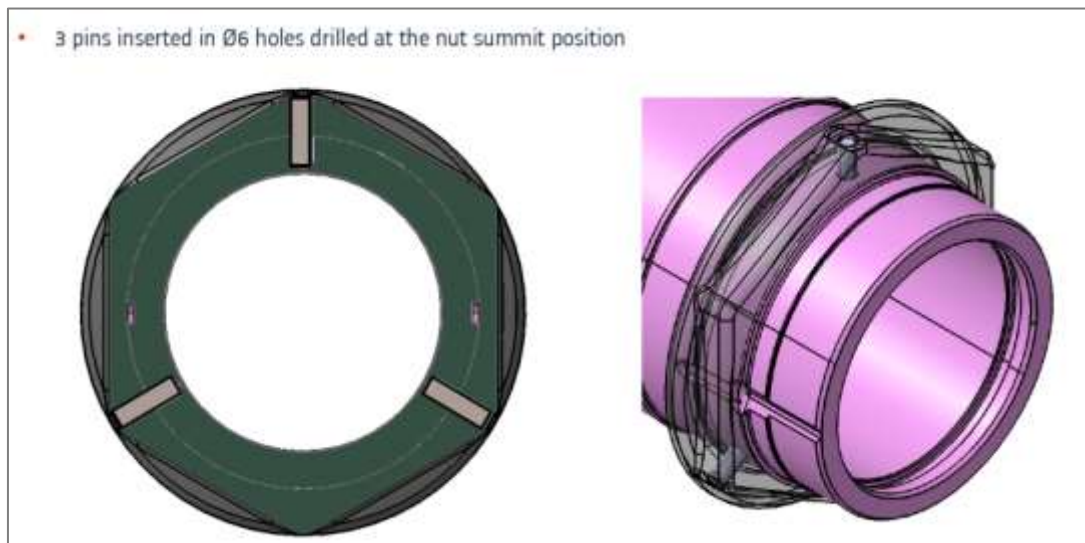
## 3.1 Containment by nut pinning

- The Nut unscrewing is the failure mode that can have a catastrophic impact
- In August 2023, the Nut pinning was proposed as an additional containment measure
- After analysis and testing, the modification was approved for deployment in the fleet in January 2024
- Full fleet deployment will allow changes to the containment plan detailed in the Alstom Safety Note

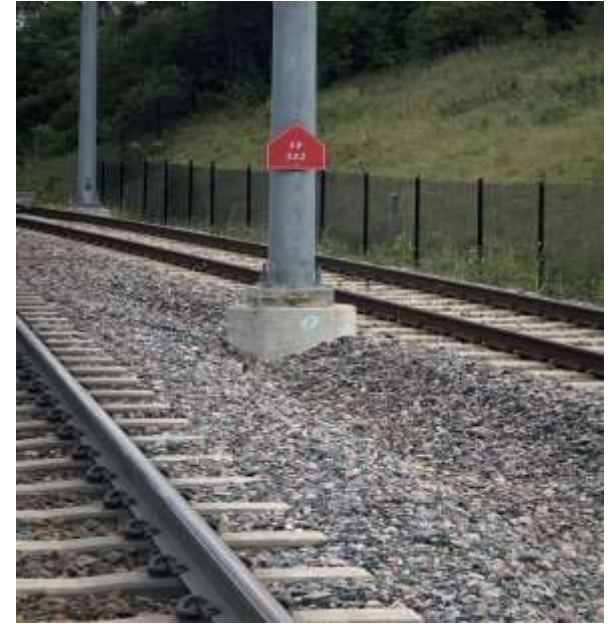
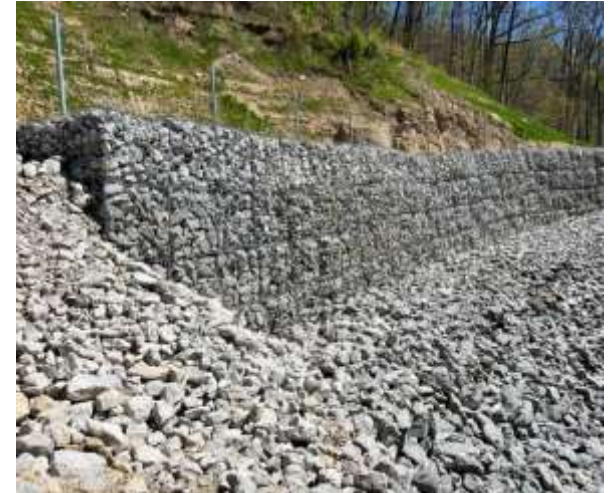
## 3.4 Track stability at high temperatures

- The Confederation Line infrastructure in at grade areas is mainly ballasted track
- Ballast maintenance is one of the key components to restrain lateral track movement to avoid buckles and kinks.
  - Last campaign in Summer 2021
  - Next campaign is scheduled for Fall 2024
- RTG/RTM have also been analyzing areas where a retention system can help to maintain the stability of the ballast

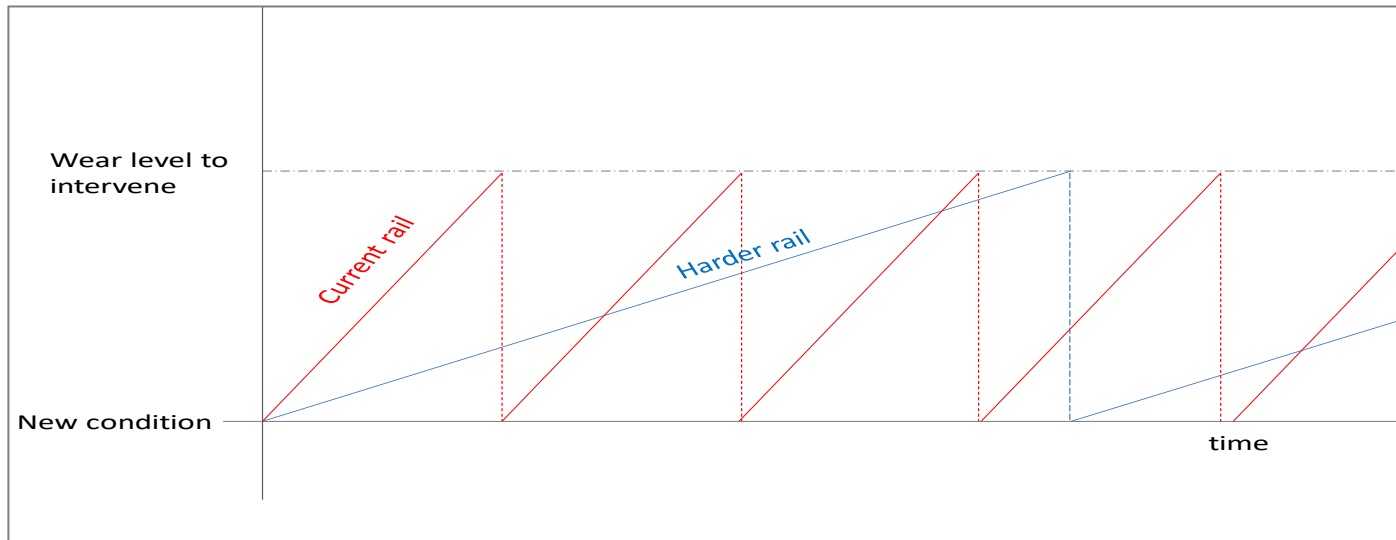
## 3.5 Reduction of rail wear and corrugation

Rail wear and corrugation are two concerns raised by Alstom with their recommendation to replace the rail in tight curves with harder rails.

- A harder rail does not avoid corrugation or gauge wear, it only impacts the wear rate
- Flange lubrication is the most effective method to reduce gauge wear in curves
- Top-of-Rail Lubrication will reduce corrugation and rail head wear
