# **January 4 Line 1 service disruption Root cause analysis**

Transit Commission  
February 9, 2023

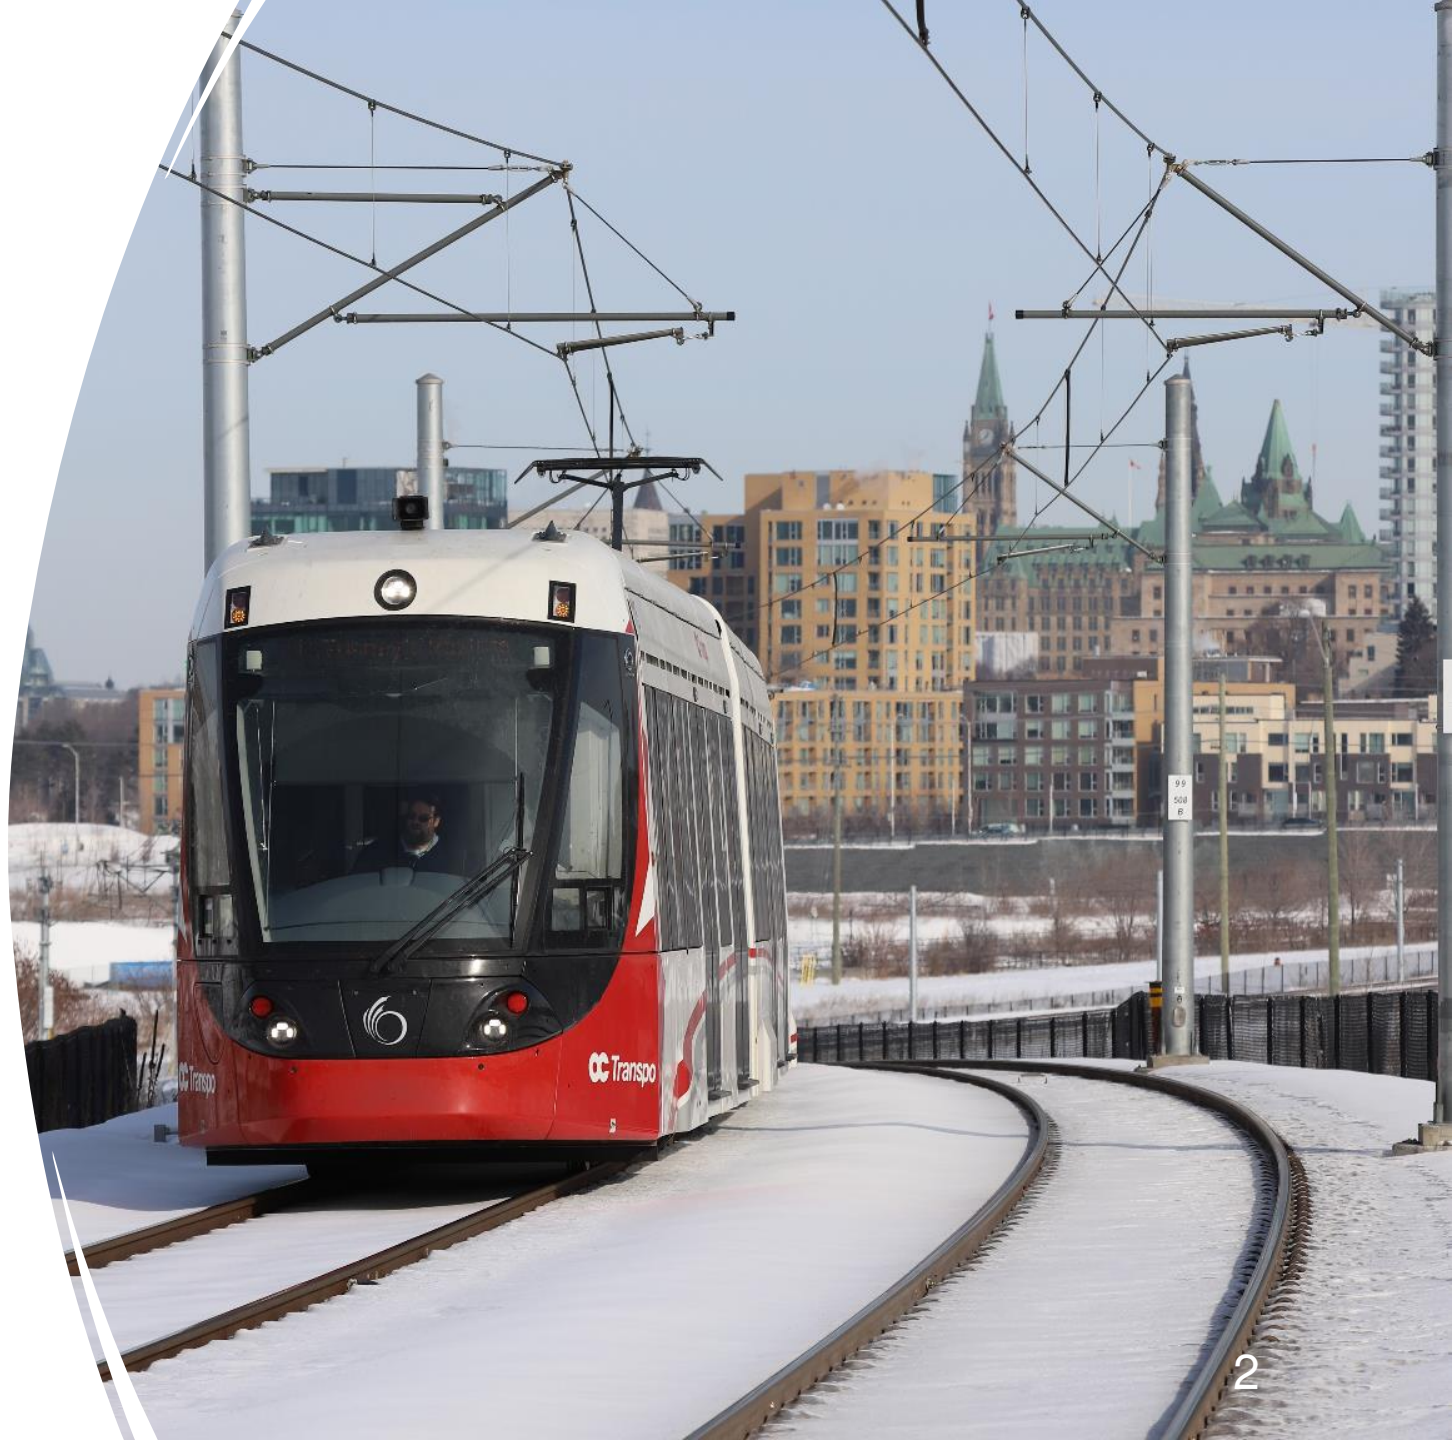
# System design

- Project Agreement:
  - Vehicles built to withstand up to 5mm/hour and 30mm/day of freezing rain
  - OCS designed for 12.5mm of ice accumulation
- 2019 to 2022:
  - 50+ days of freezing rain events
  - Zero ice-related OCS issues
