**CBA Issues  
Update to the Transit Commission**

**May 31, 2024**

**CONFEDERATION LINE PROJECT:  
TUNNEY'S PASTURE TO BLAIR STATION**

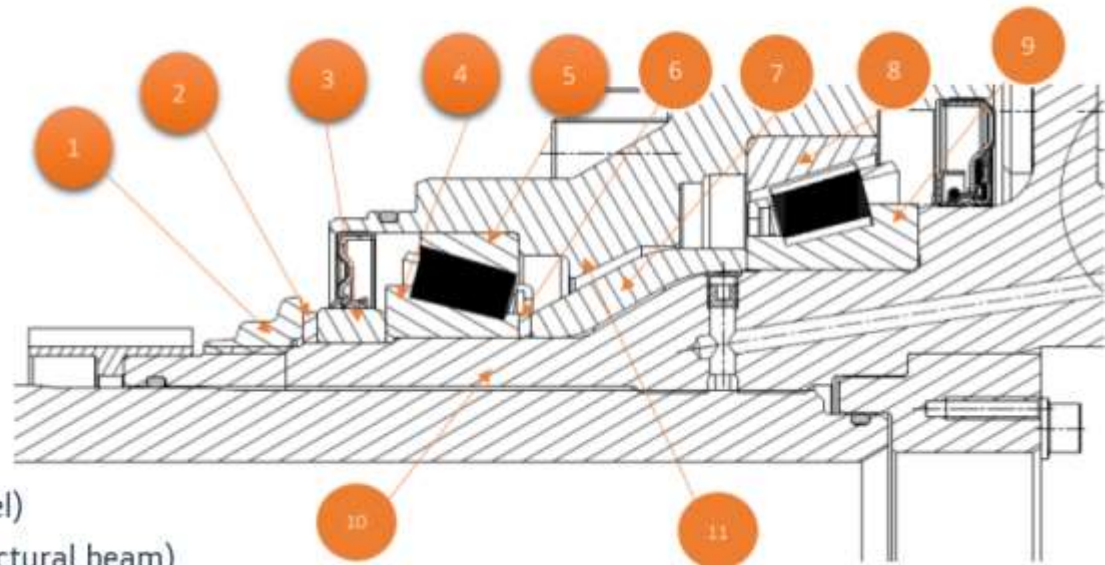
## Evolution of Alstom's understanding of the Issue

Excessive lateral loads generated by the design of the track

Inducement of excessive lateral loads from the System

The root cause of the high loads is the Wheel/Rail Interface, which includes the integrated combination of the wheel profile, rail profile, track and rail geometry and coefficient(s) of friction at the interface (TOR and rail gauge face)

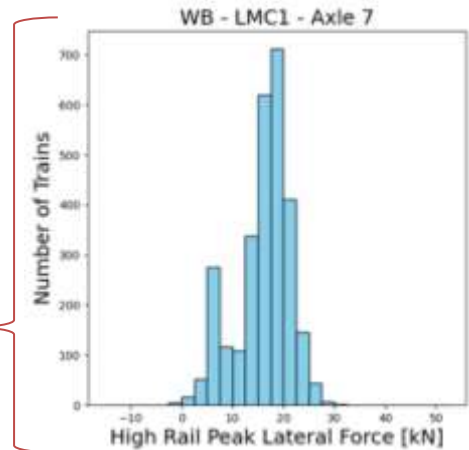
WB-280 peak high rail lateral force when LMC1 is the leading unit

Axle	95 <sup>th</sup> percentile [kN]	Median [kN]	Mean [kN]
1	36.56	30.54	27.69
2	2.33	-4.51	-3.55
3	26.51	20.51	19.26
4	4.39	-1.44	-0.67
5	28.11	22.45	20.7
6	3.04	-2.83	-2.25
7	23.17	17.13	16.06
8	6.35	1.97	2.01
9	32.77	25.97	23.51
10	4.22	-3.28	-2.4

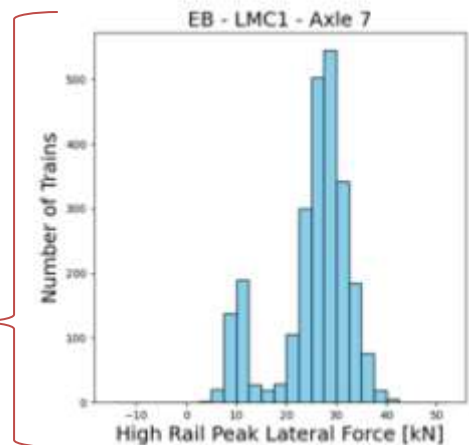
EB-280 peak high rail lateral force when LMC1 is the leading unit

Axle	95 <sup>th</sup> percentile [kN]	Median [kN]	Mean [kN]
1	49.71	41.67	37.83
2	6.22	-5.53	-4.13
3	37.72	30.93	28.57
4	4.88	-1.38	-0.46
5	44.25	35.25	33.1
6	5.73	-3.21	-2.34
7	34.38	27.09	25.35
8	5.54	1.27	0.61
9	47.99	39.27	36.16
10	7.73	-4.24	-2.59
